**REMARKS**

#### Criticality of the 1-2mm Range

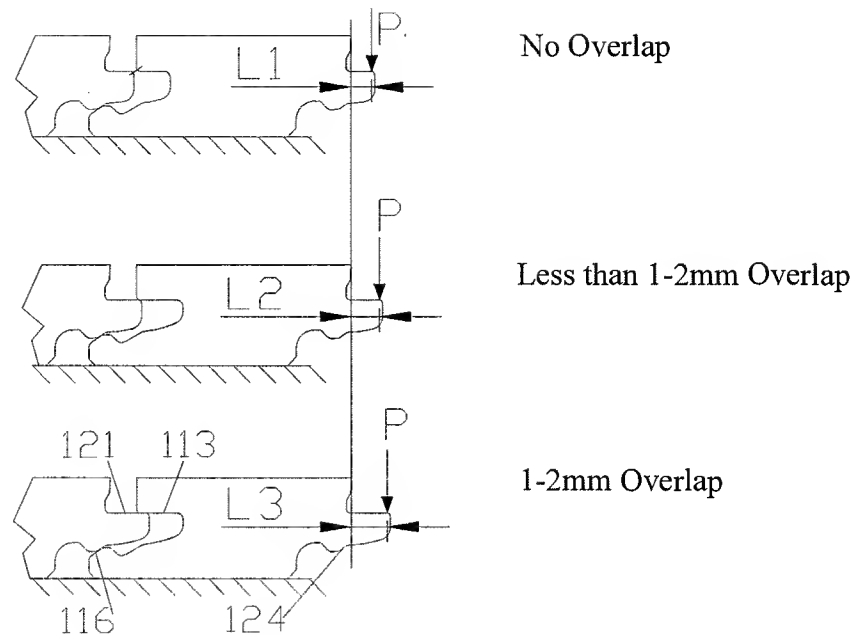
FIG. A

Applicant has discovered that the tenon length has a direct effect on flexural stresses encountered when floorboard pieces are assembled horizontally. In floorboards, when the flexural stress is unchanged, the larger the length  $L$ , the smaller the pressure  $P$ . In other words, there is an inverse proportional relationship between the pressure  $P$  required to bend the floorboard tenon and the tenon length  $L$ . Assuming the same floorboard material, the longer the tenon, the easier elastic deformation (bending) will occur. Thus, in floorboard structures that adopt a tenon-slot mortise engagement, the tenon structure of a smaller flexural strength is easier to guide into the slot mortise to achieve full engagement. The below Fig. A shows three different tenon lengths that were examined by Applicant; no overlap; less than 1-2mm overlap and 1-2mm overlap.

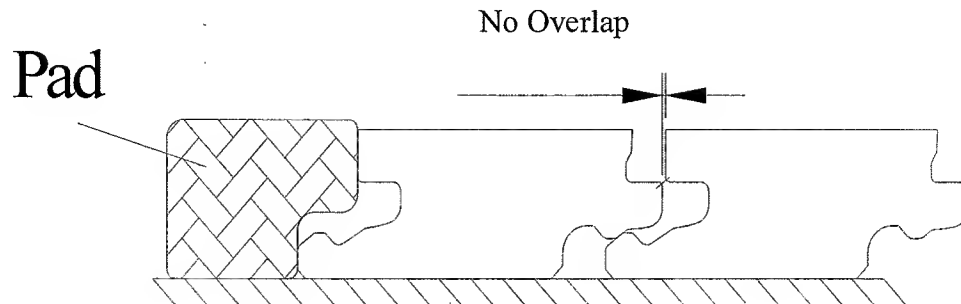
Fig. B1

As shown in the below Figs. B1-B3, when there is no overlap between the upper surfaces of the tenon and the slot mortise before deflection of the lower surface of the slot mortise during horizontal assembly, the floorboard is damaged during installation. Specifically, when assembled horizontally, the tenon moves along the slot mortise's beveled surface the front end of the tenon is pushed against the slot mortise (Fig. B2). If a horizontal force is continued to be applied, the front end of the tenon and the end of the slot mortise are damaged and the tenon cannot be guided into the slot mortise (Fig. B3). As such, correct installation of the floorboard cannot be accomplished when there is no overlap between the upper surfaces of the tenon and the slot mortise before deflection of the lower surface of the slot mortise during horizontal assembly.

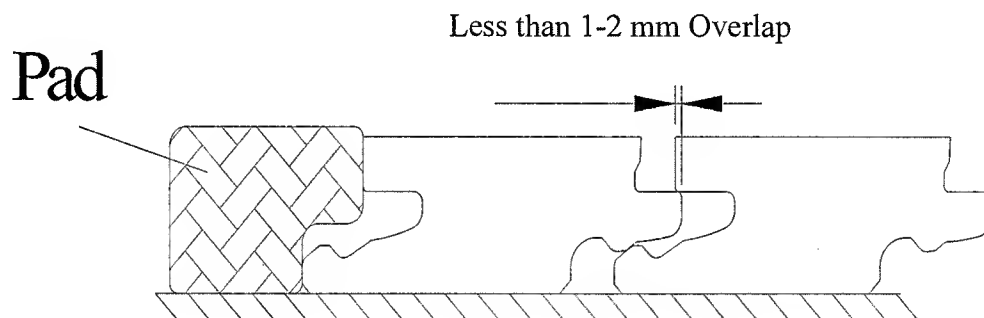
Fig. C1

As shown in the below Figs. C1-C3, when there is less than 1-2 mm overlap between the upper surfaces of the tenon and the slot mortise before deflection of the lower surface of the slot

mortise during horizontal assembly, the floorboard is damaged during installation. Specifically, when assembled horizontally, the tenon moves along the slot mortise's beveled surface contact area between the upper surface of the tenon and the upper surface of the slot mortise is small (Fig. C1). If a horizontal force is continued to be applied (Fig. C2), the small contact area will cause excessive local pressure to be applied, sharply increasing the friction resistance on the contact area, and thereafter causing local plastic deformation (damage), as shown in Fig.C3. In particular, the contact between surfaces 121 and 113 in Fig. C2 cause bulging deformation, which directly affects the tightness and neatness of the floorboard joints, and results in deformation and cracking at such joints. As such, correct installation of the floorboard cannot be accomplished when there is less than 1-2 mm overlap between the upper surfaces of the tenon and the slot mortise before deflection of the lower surface of the slot mortise during horizontal assembly.

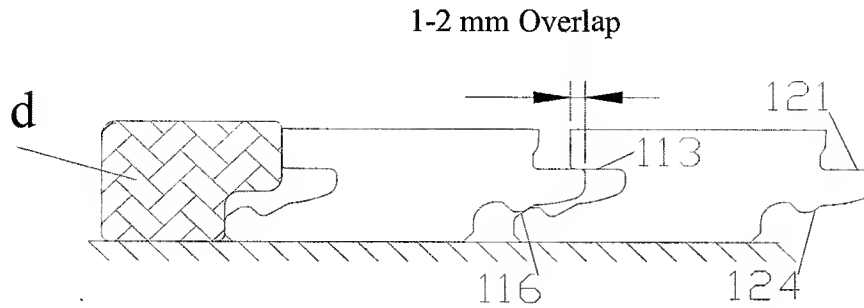
Fig. D1

However, as shown in the below Figs. D1-D3, when there from 1-2 mm in overlap between the upper surfaces of the tenon and the slot mortise before deflection of the lower surface of the slot mortise during horizontal assembly, the floorboard is not damaged during installation. When assembled horizontally, the tenon moves along the slot mortise's bevel surface 116 and a pressing force is generated between plane 113 and plane 121 (Fig. D1). During the continued horizontal assembly, the tenon front end will be experience downward elastic bending deformation and the slot mortise will be subject to upward elastic bending deformation (Fig. D2). Specifically, during the process of the tenon being guided into the slot mortise, pressure generated on the tenon upper surface and the slot mortise upper surface acts on sufficiently large contact area, thereby dispersing the pressing force and avoiding excessive pressure and friction resistance. That is to say, no plastic deformation occur on the tenon and the slot mortise contact surfaces. As such, the tenon can be smoothly guided into position in the slot mortise after being subject to elastic deformation, and then restored to its original position (Fig. D3). Therefore, correct installation of the floorboard is accomplished when there is from 1-2 mm overlap between the upper surfaces of the tenon and the slot mortise before deflection of the lower surface of the slot mortise during horizontal assembly.

As discovered by the Applicant, and shown above, before the tenon needs to be guided into the slot mortise by a depth of 1-2mm during horizontal assembly so as to avoid damage to the floorboard and ensure a smooth installation.

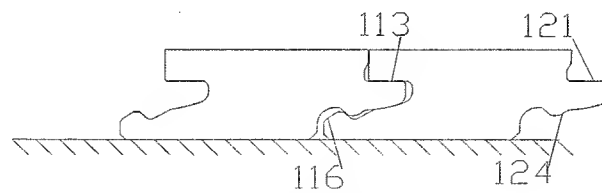
Fig. D3

Undamaged Floorboard
